Scott Busyn  
Great Neighborhood Homes, Inc.  
3939 West 50<sup>th</sup> Street, Suite 103A  
Edina, MN 55424

May 4, 2022

**Subject: Deteriorated Chimney at 4630 Drexel Avenue**

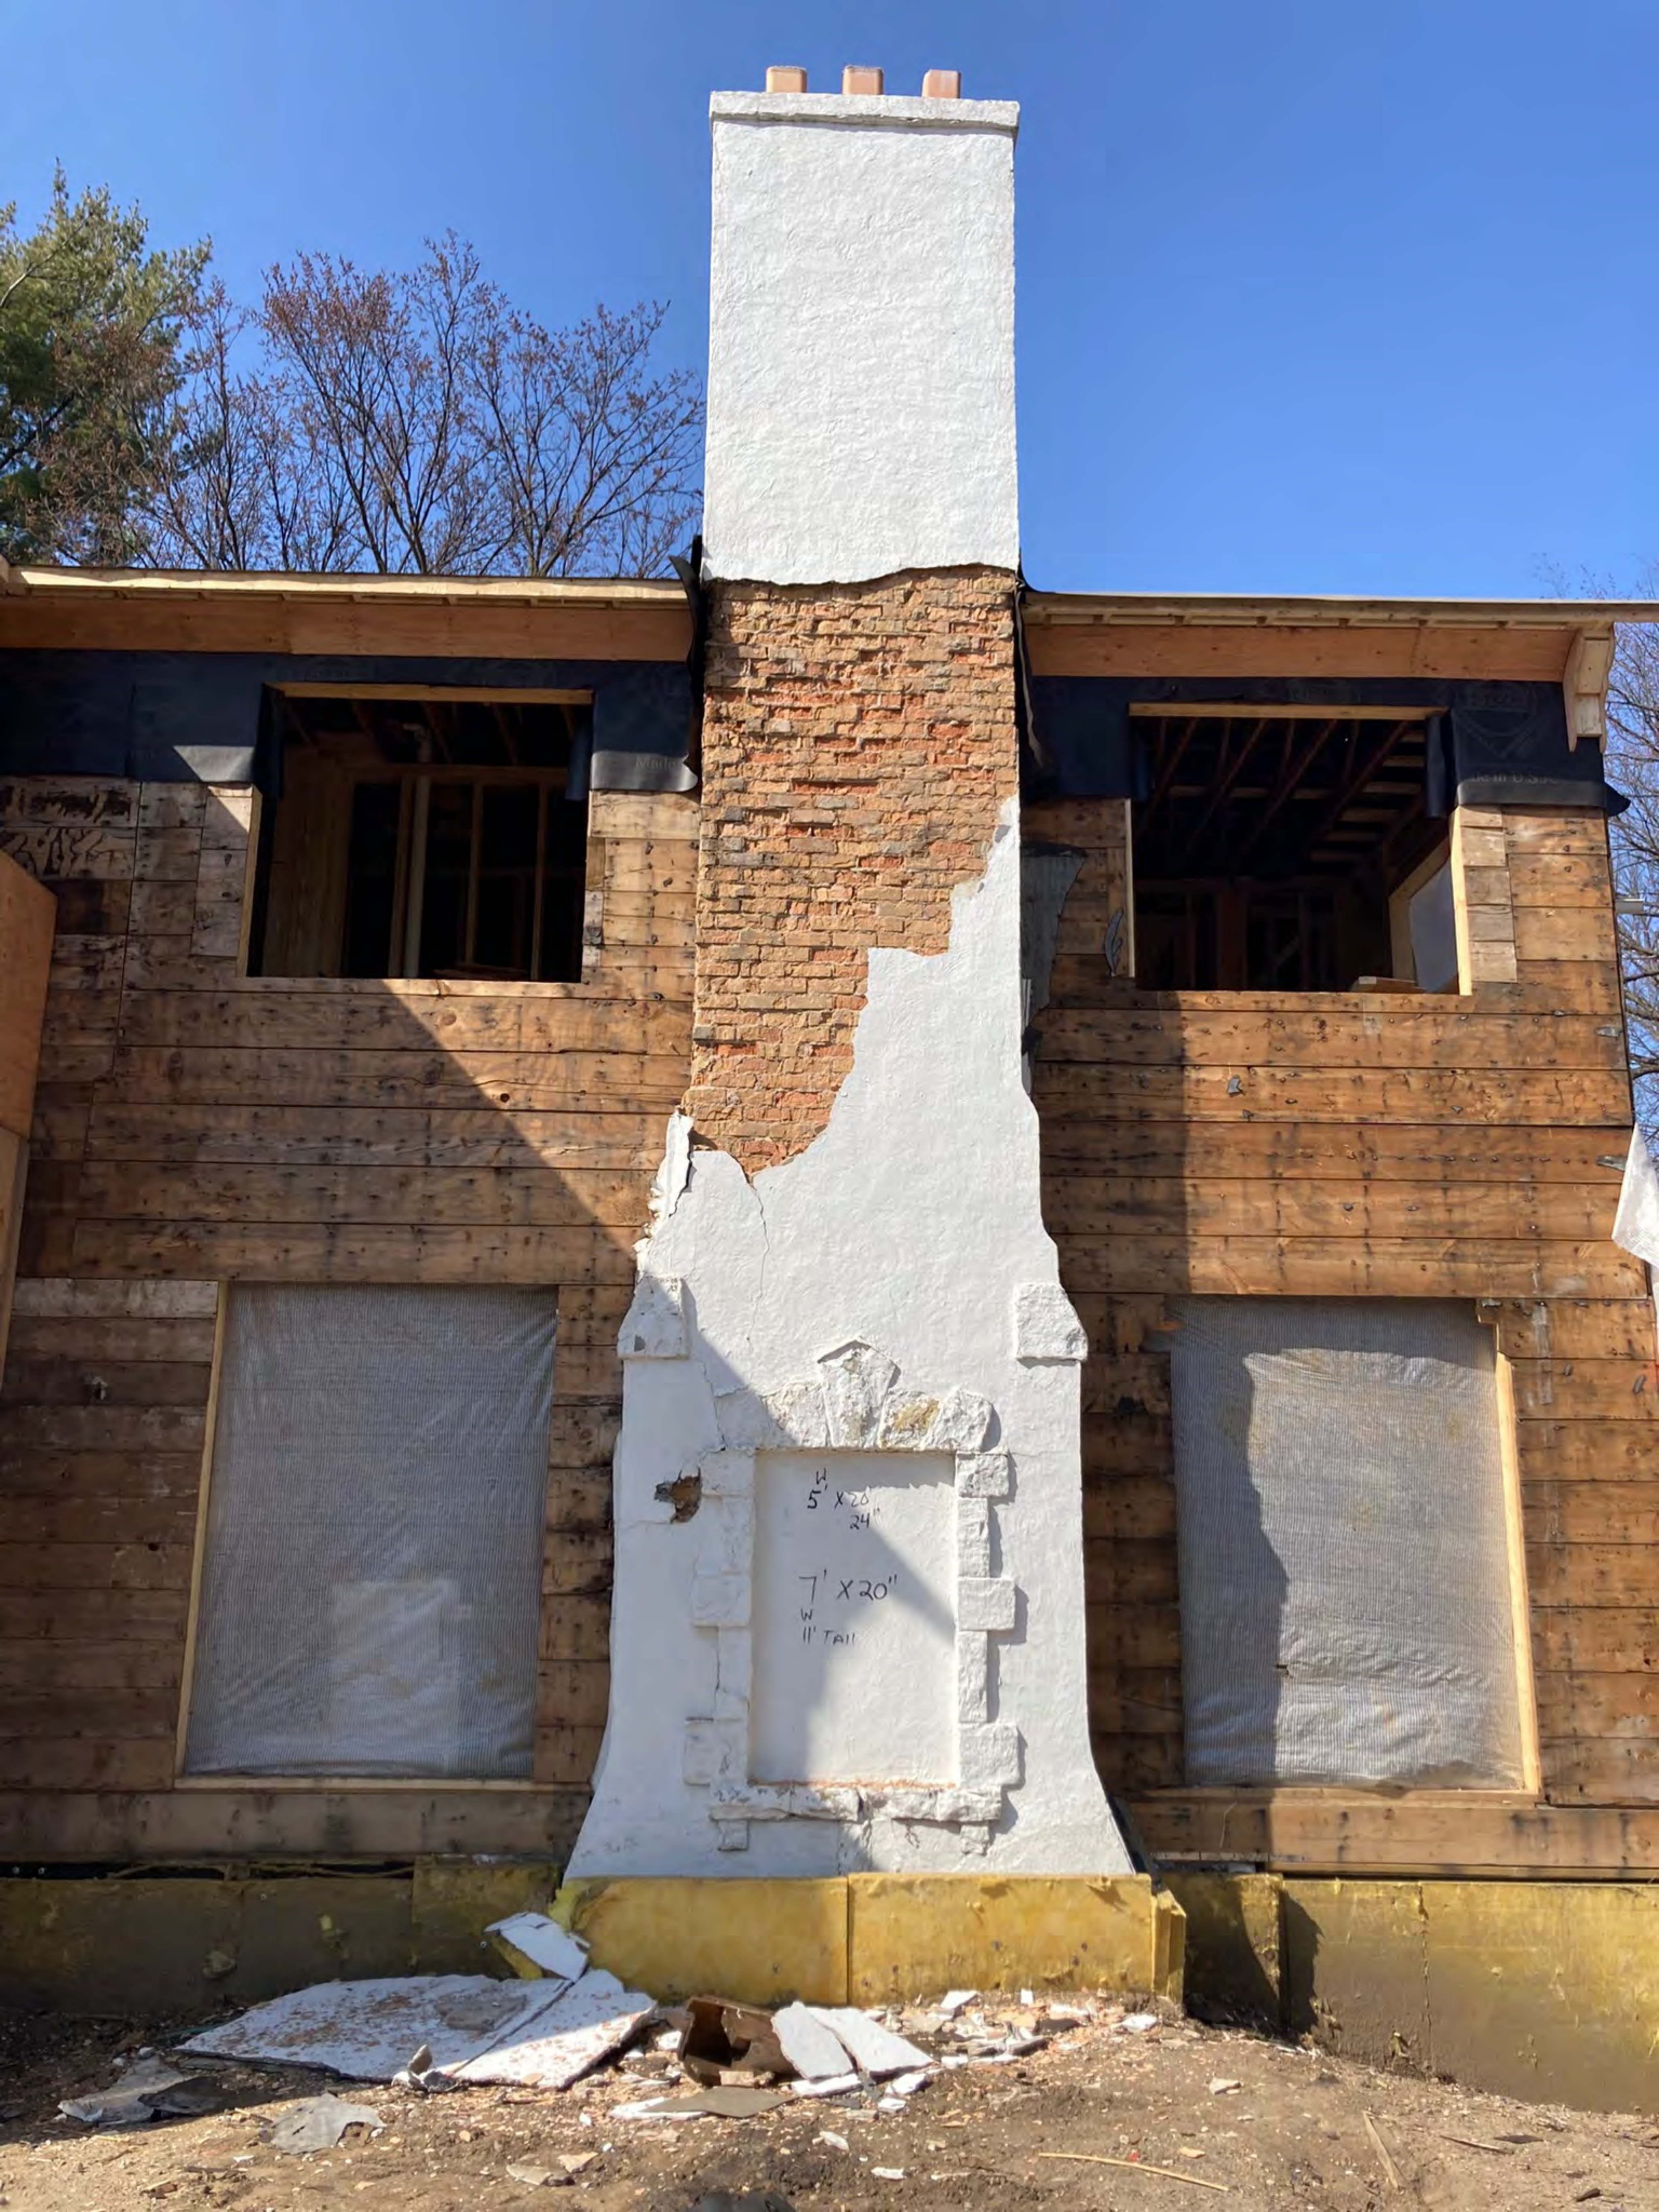
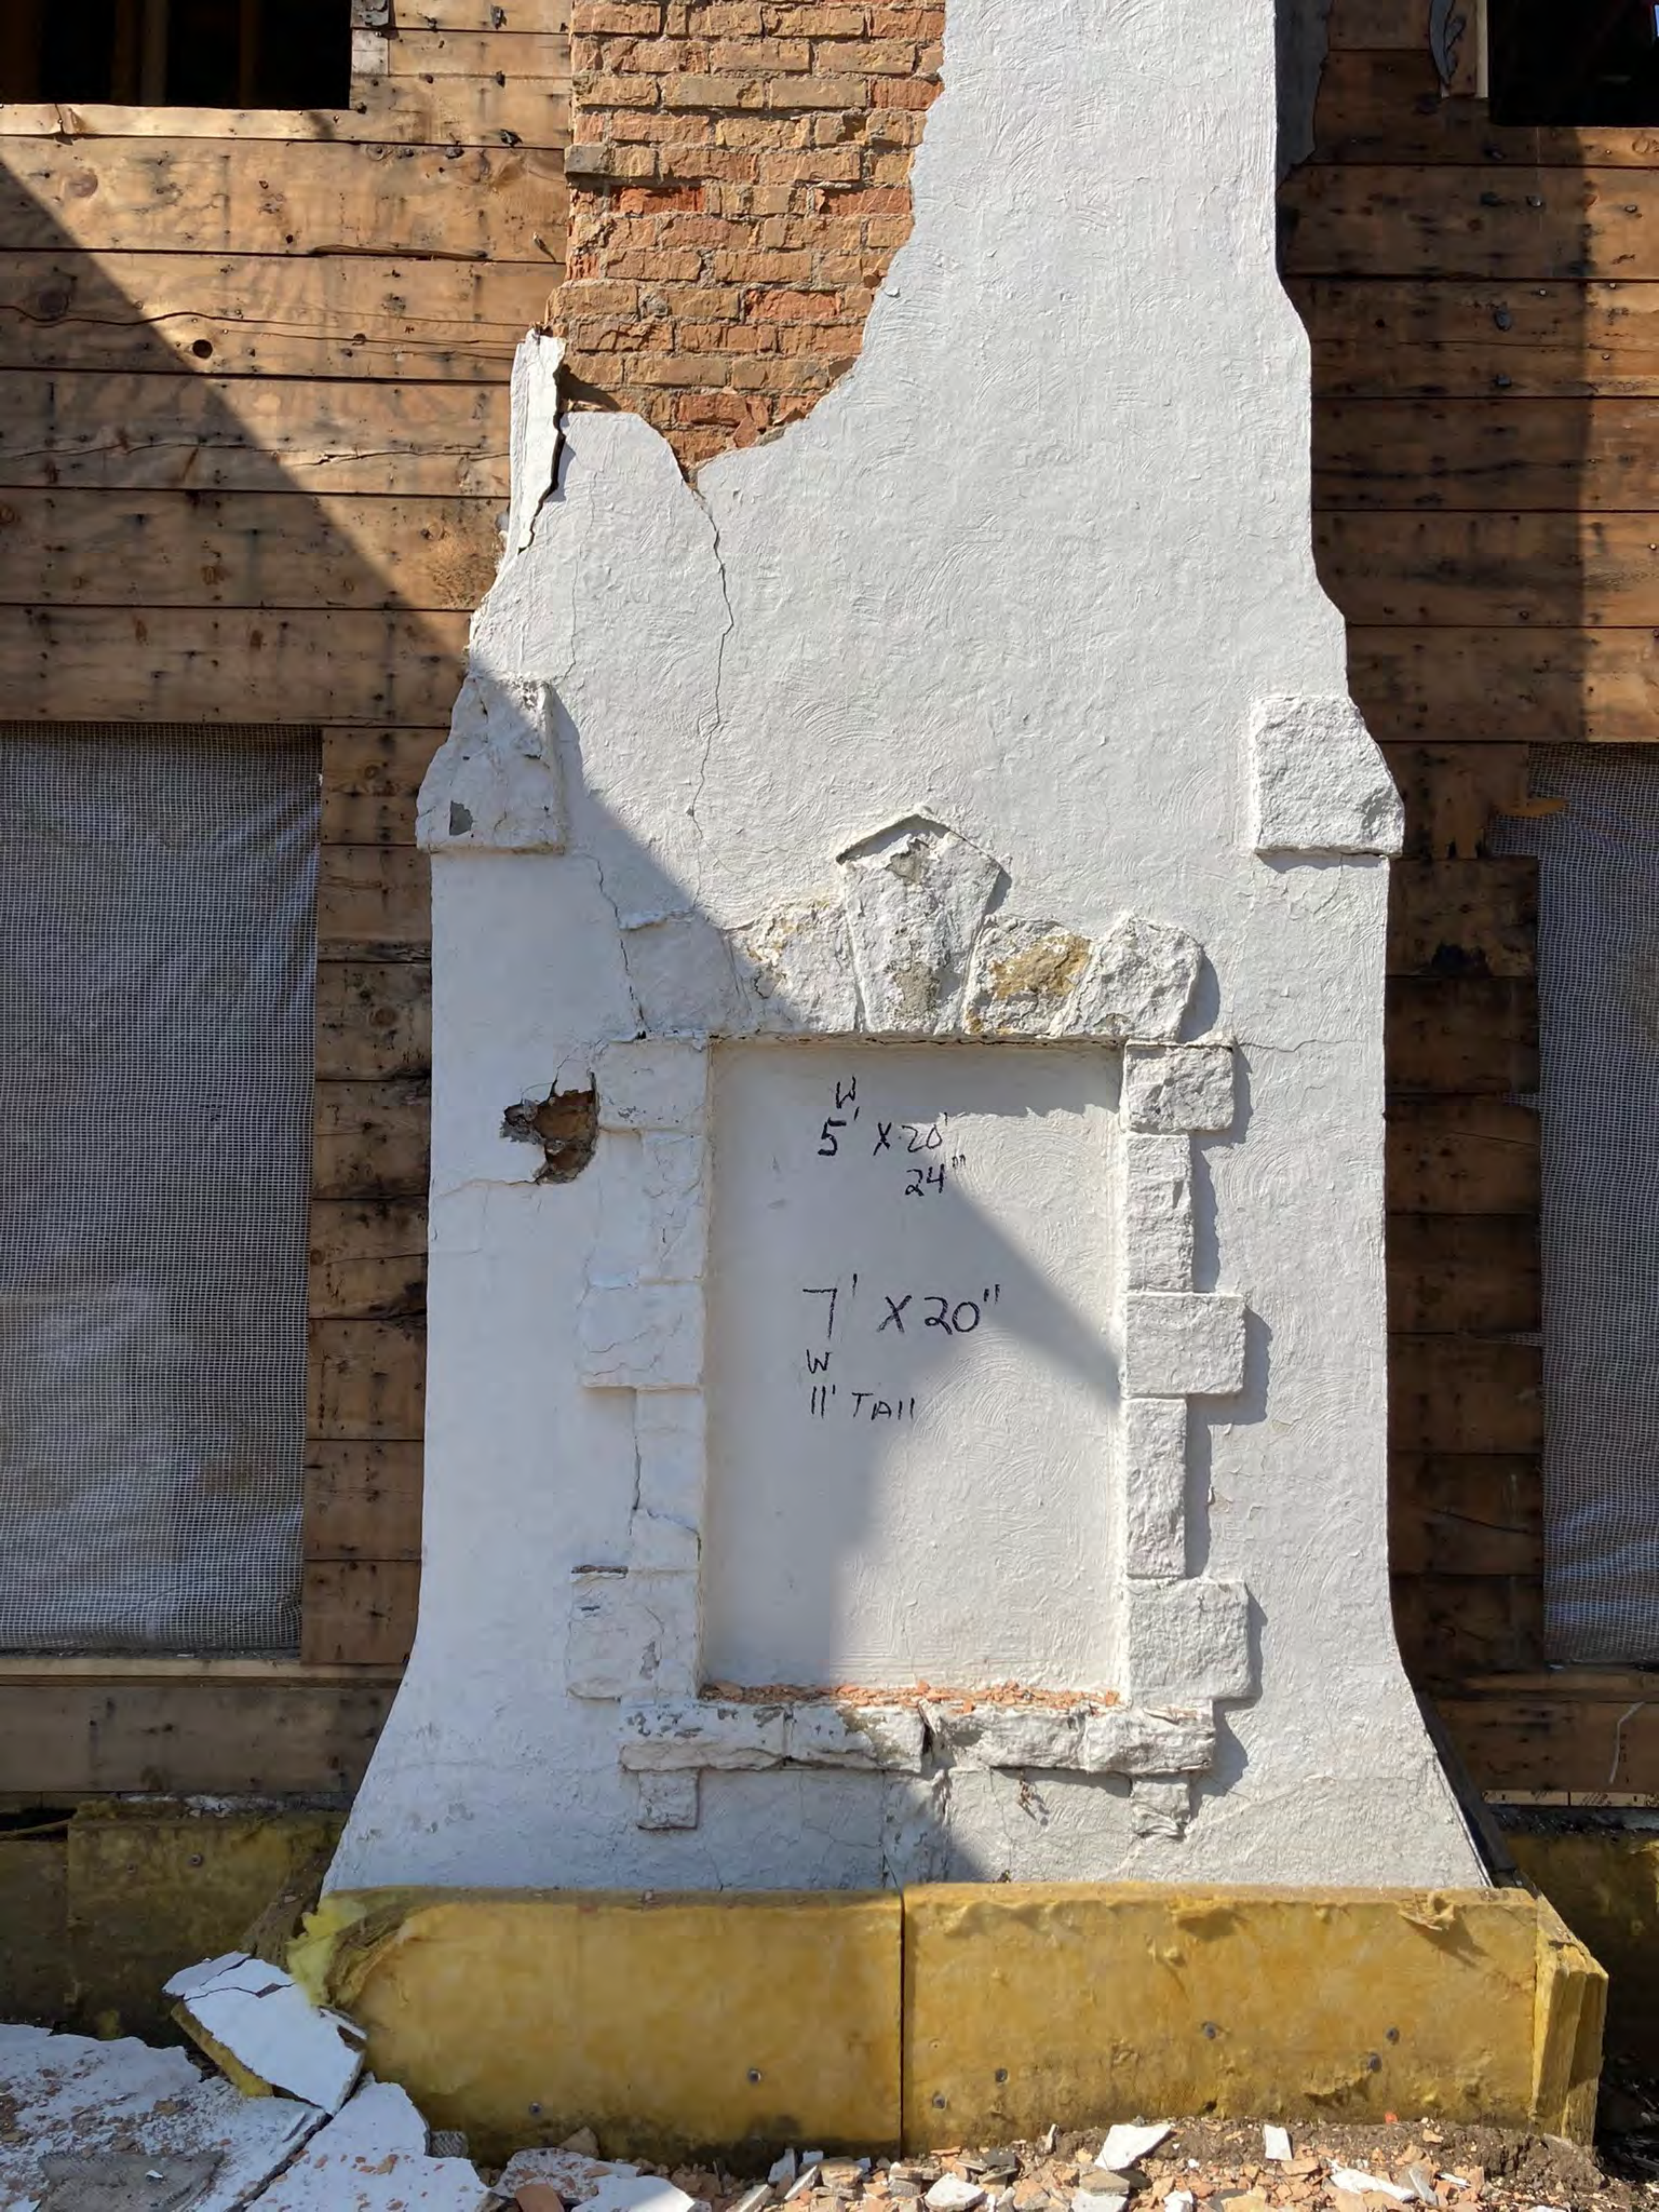
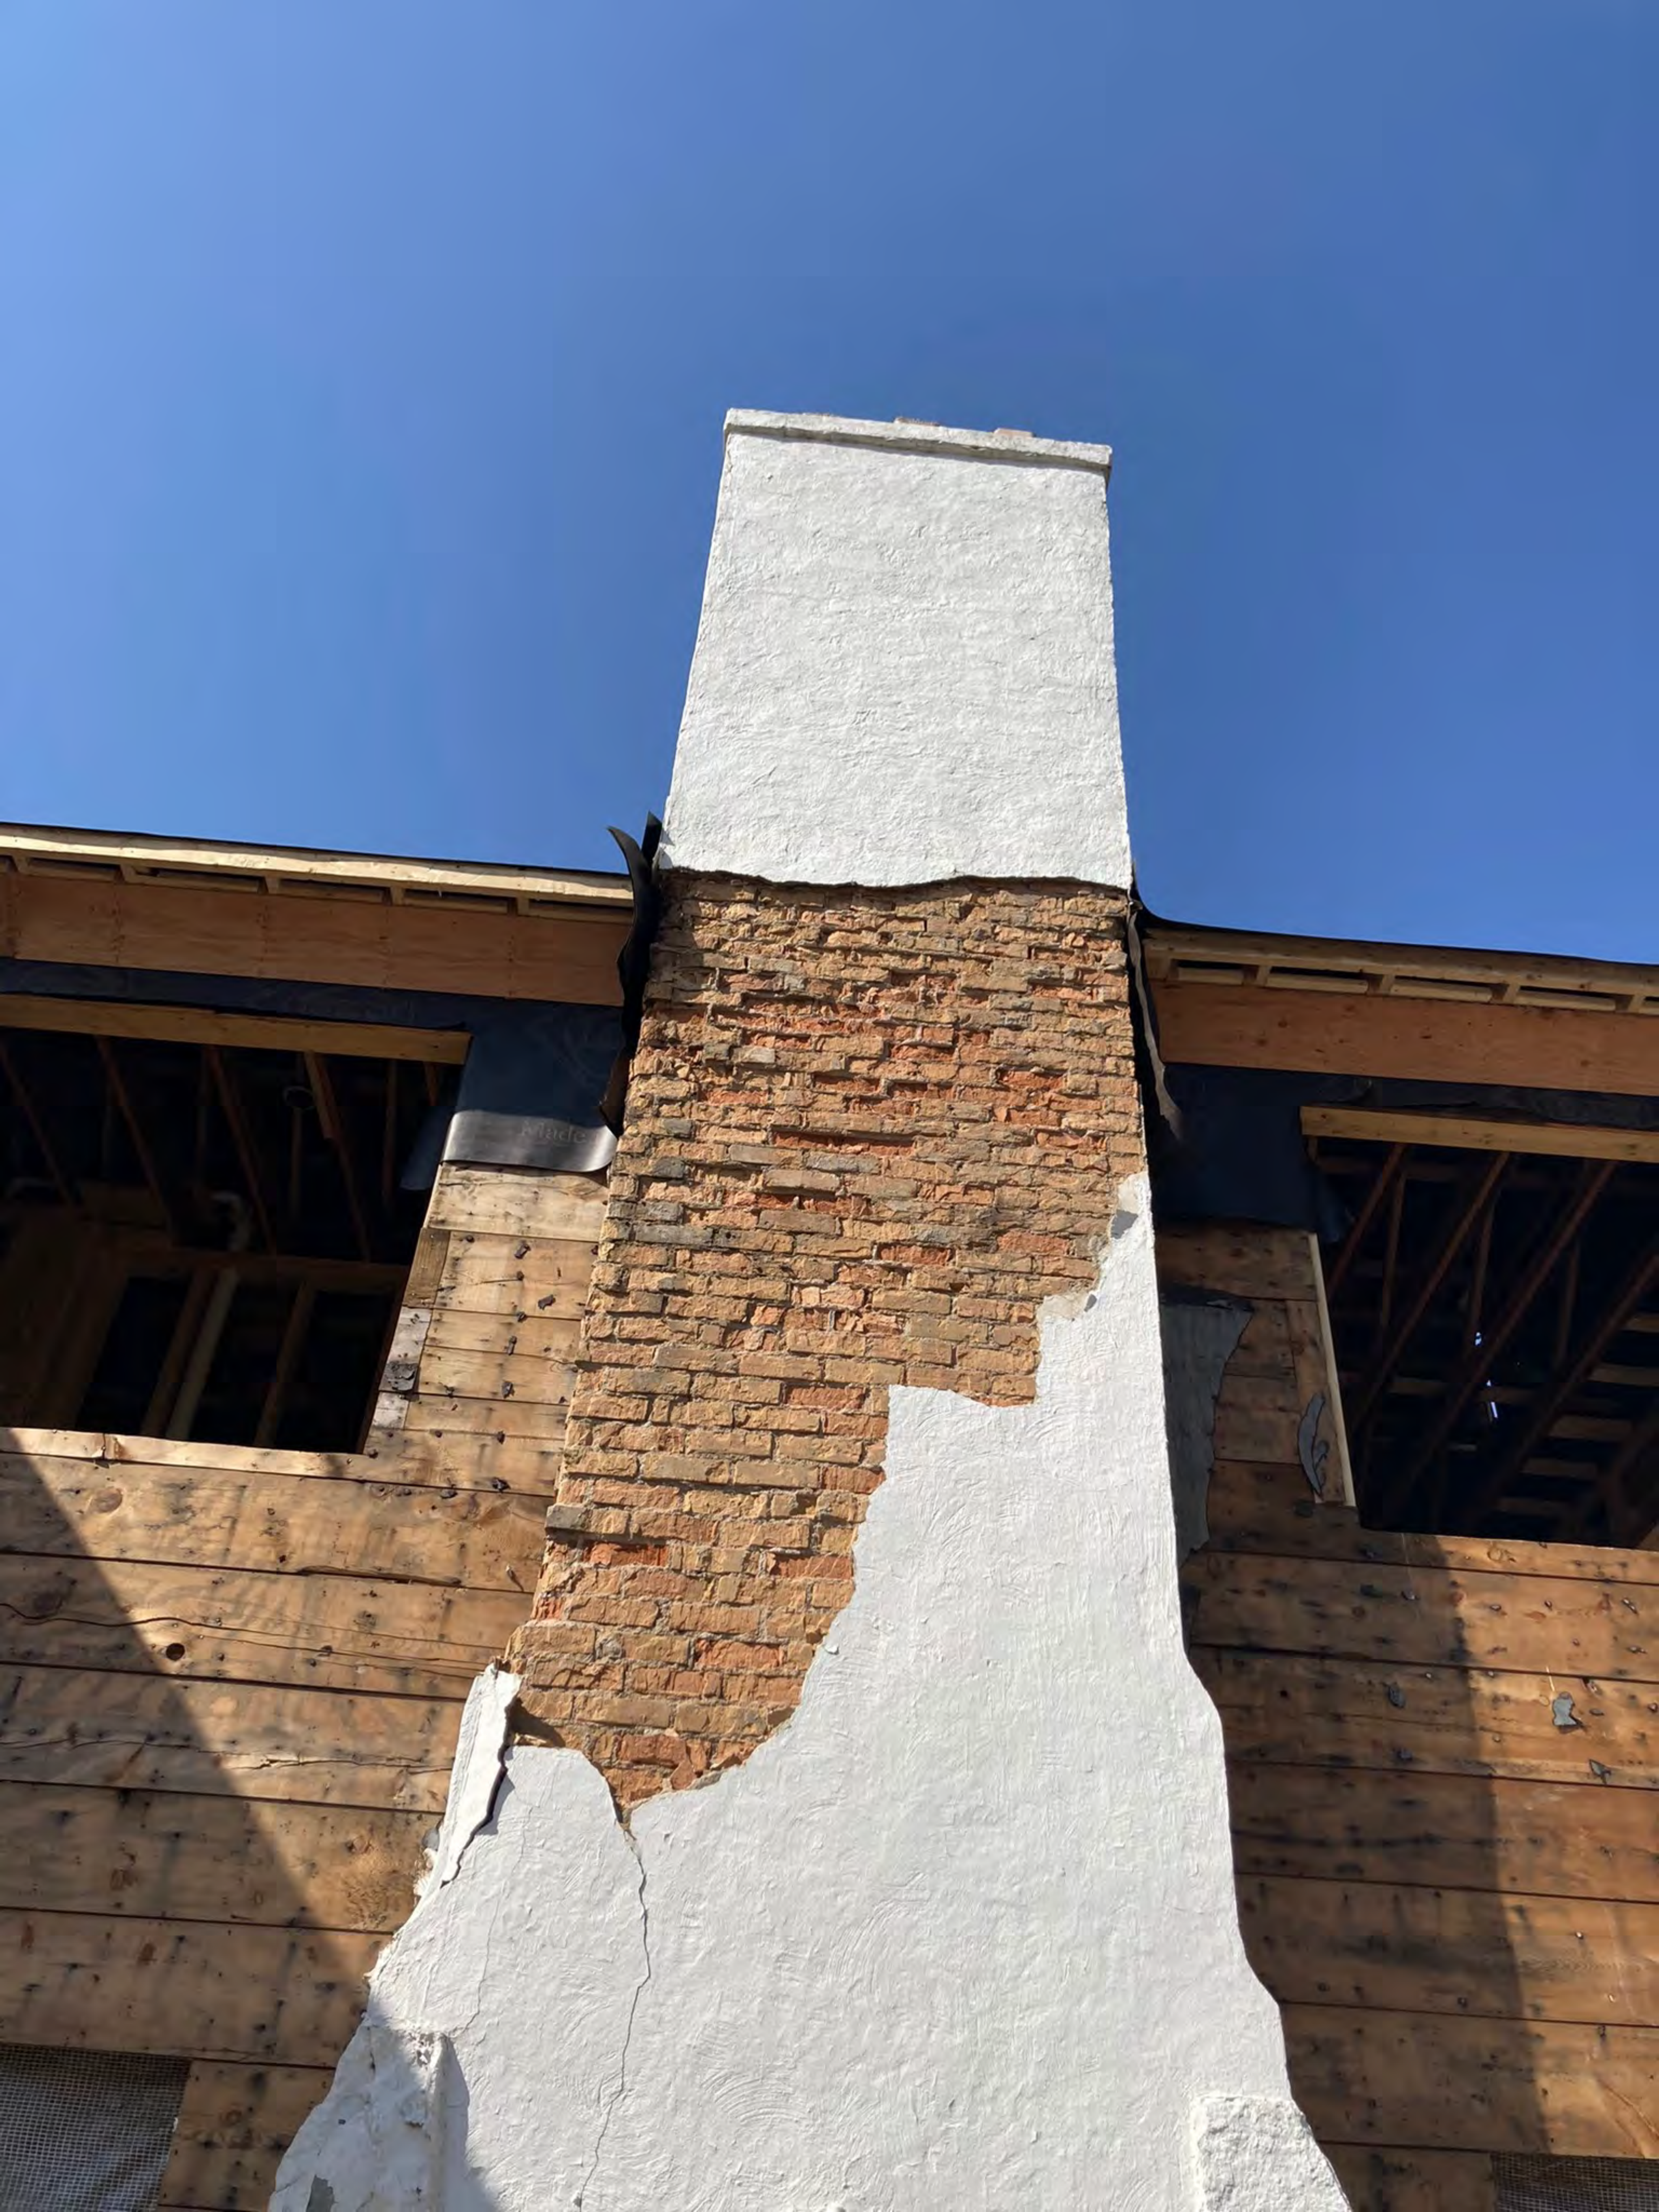
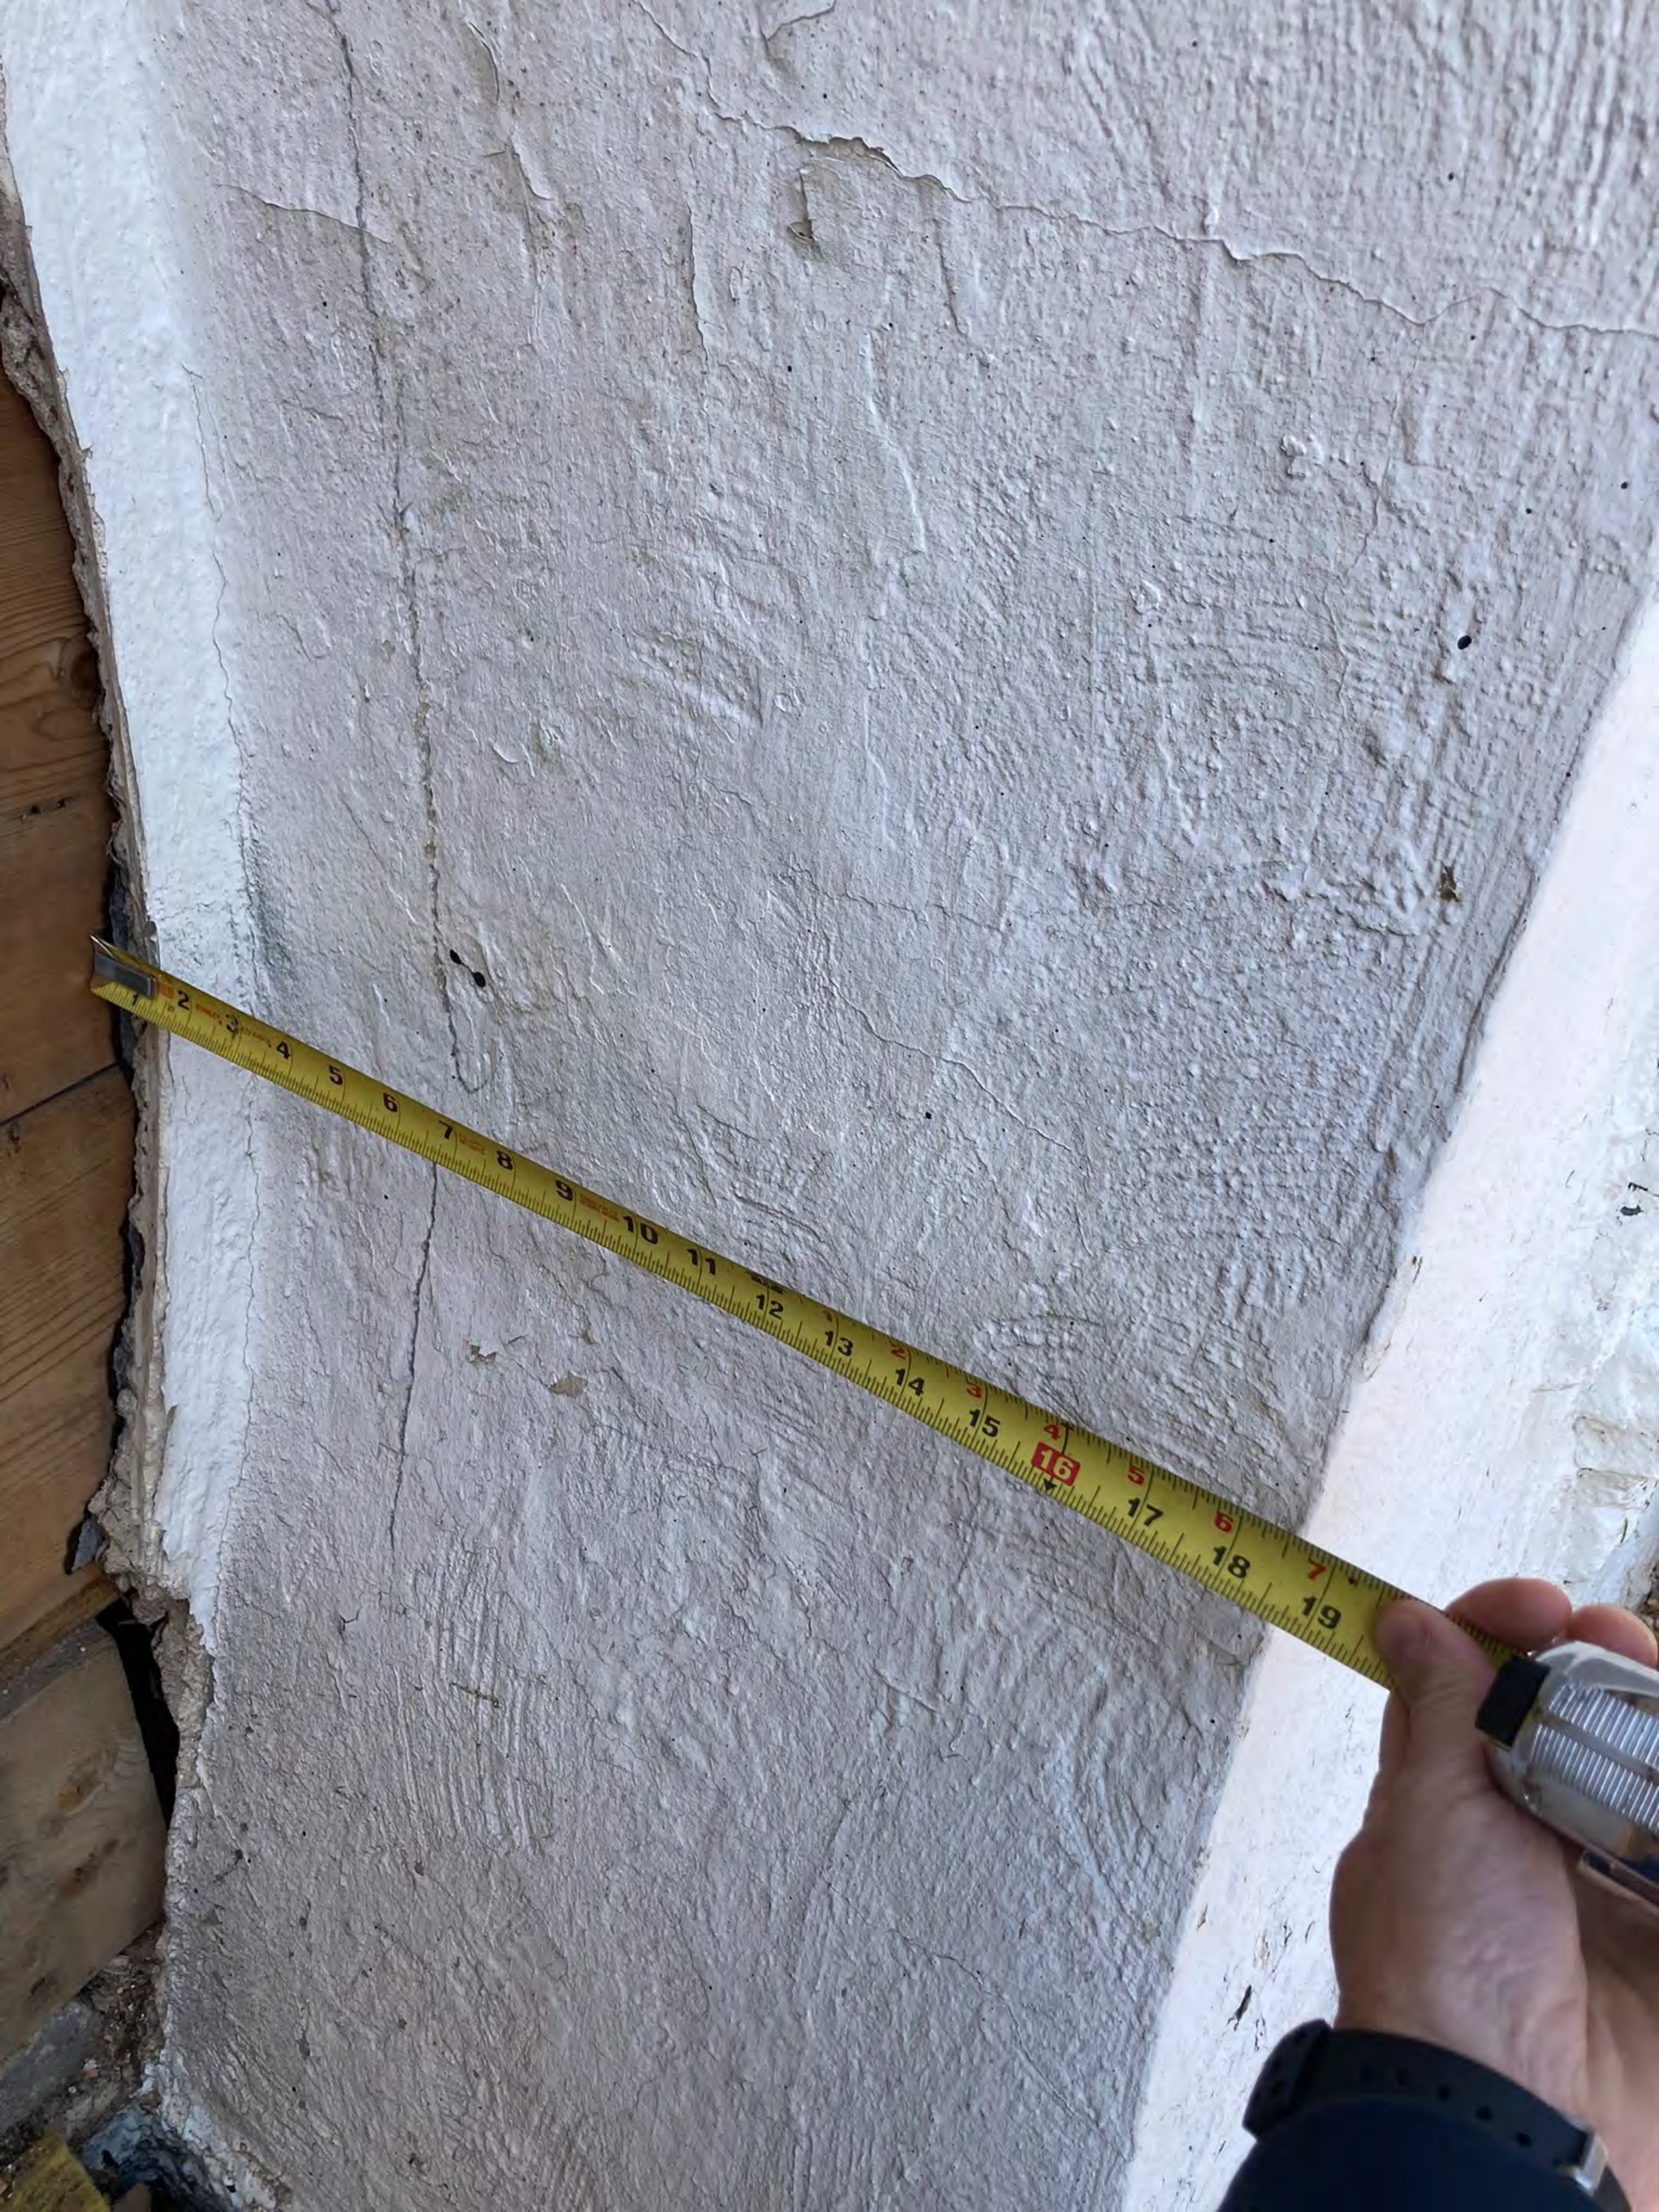
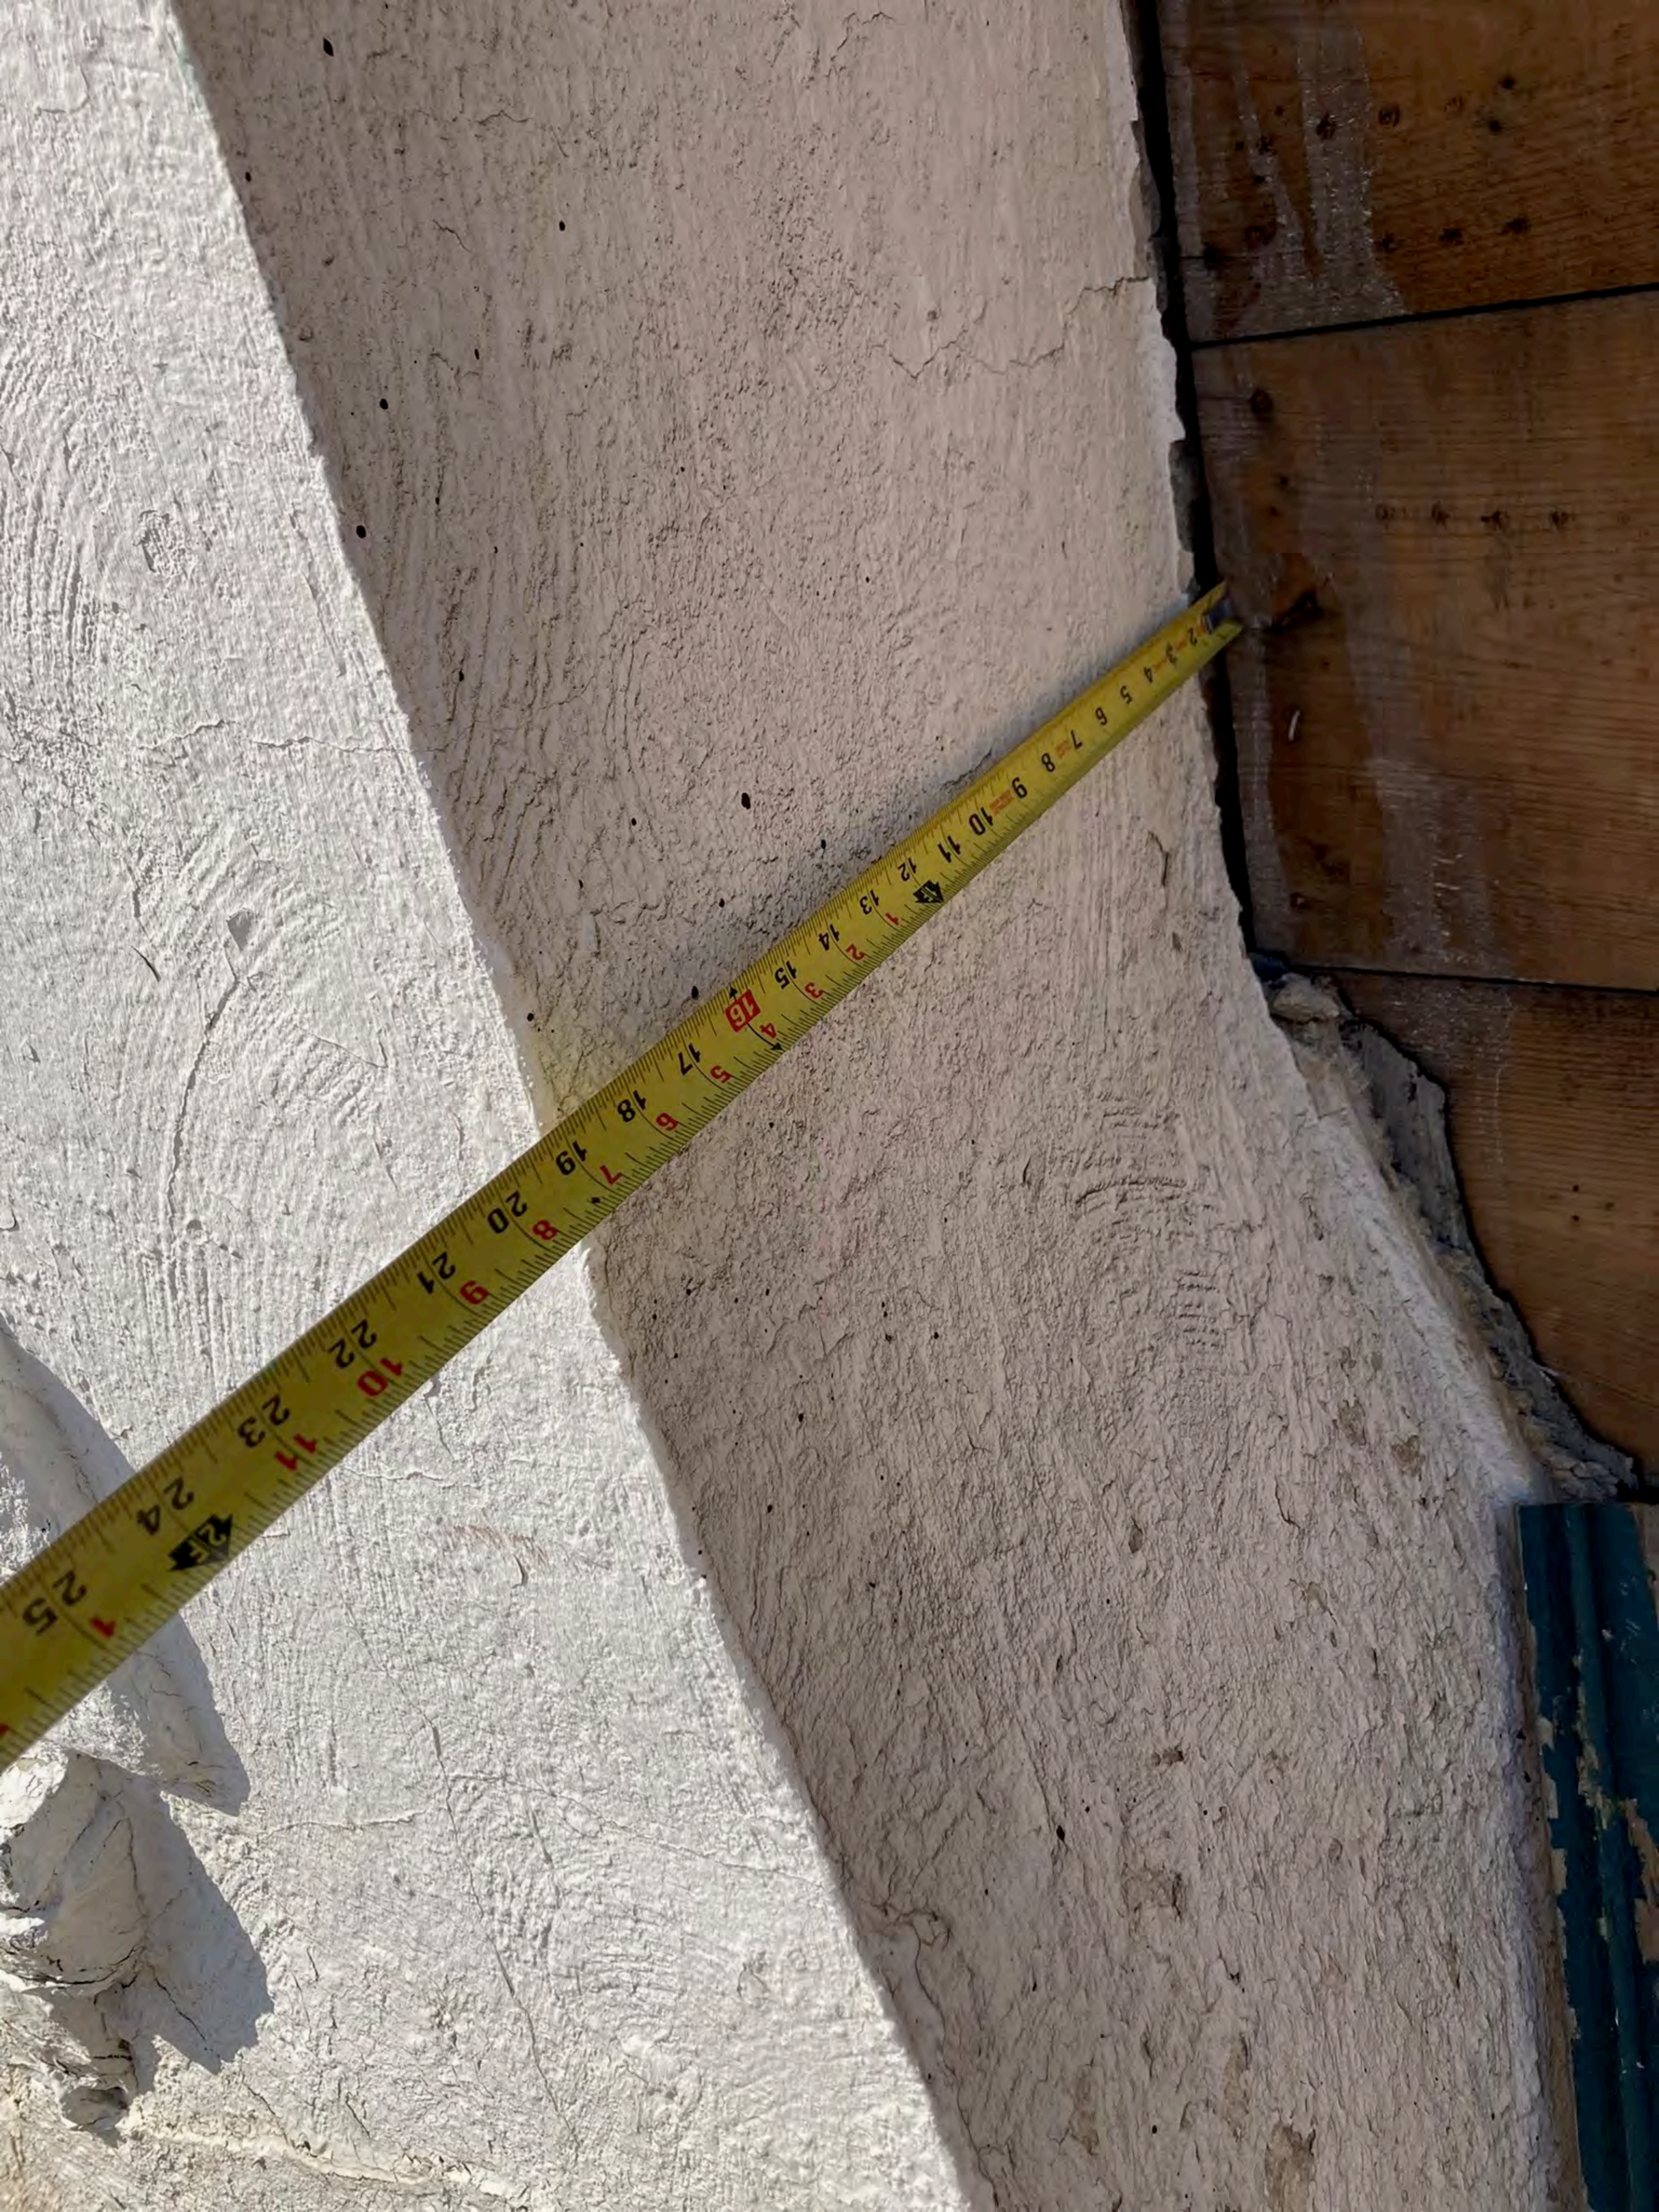
Thank you to Chief Building Official Dave Fisher and yourself for meeting us at the 4630 Drexel Avenue job site to review the existing chimney. Recapping our discussion, we pointed out to you and Dave that the existing chimney was structurally unstable due to decades of water intrusion from the top of the chimney and improper flashing. We pointed out that the structural brick was mushy and crumbly throughout the chimney structure. There were also structural cracks throughout the chimney. One of our workers stated he could move the chimney by leaning on it while working on the roof. Dave Fisher inspected the chimney and ruled that the chimney was structurally unsafe and should be removed due to it being a hazard. I attached photos of the deterioration as well as an inspection report from the mid-1980s (source Edina Historical House Record Card) that that basement had a “Severe, very noticeable water problem, very frightening to a prospective buyer.” The inspection report also stated the windows had “some rotted wood.” Dave Fisher also stated at the meeting that he would be issuing a recap of his observations.

Photos of chimney deterioration
