Traffic Safety Report

November 4, 2015

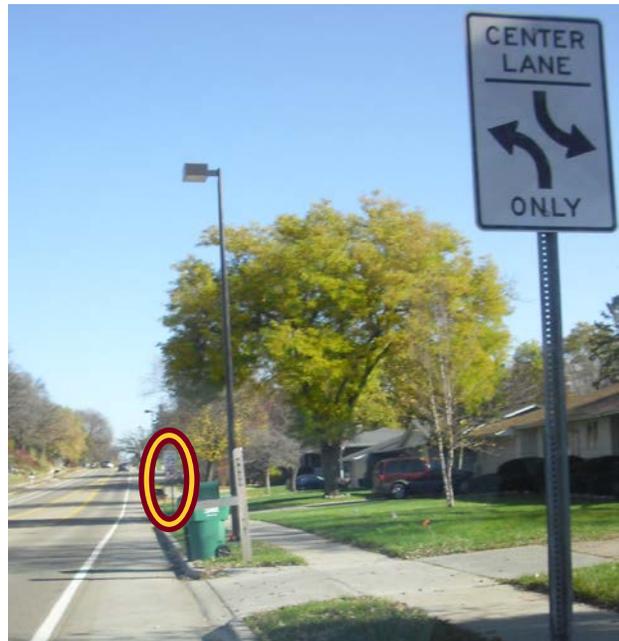
This request regards the signage on 70th Street east of Trunk Highway 100. This requestor references city maps, which show that the speed limit of 25 mph starts before the signage which informs drivers of this speed limit, and that this signage is obscured and drowned out by the amount of signage in the area as well as the geometry of the street. The speed limit sign for eastbound traffic is 184 feet from the start of the eastbound bike lane, 155 feet from the two-way left turn only lane signage, and 100 feet to the end of the westbound bike lane. Speeds on this road are seen as an issue, with an 85th-percentile speed of 33.2 mph, even after the sign, and a volume of 11,530 vehicles per day.

Photo : Center turn lane signage eastbound on 70th Street, the speed limit sign in circles in the back

After review, staff found that the bike lane marks the start of the lowered speed limit by City Council resolution and state law. Therefore the signage informing drivers of this speed limit should be further west so drivers are aware of this speed limit. Staff recommends adding the speed limit signage to the post which currently has the Two-Way Left Turn Lane signage, and moving the center turn lane signage down on the post, such that the speed limit signage is in the current location of the center turn lane signage.

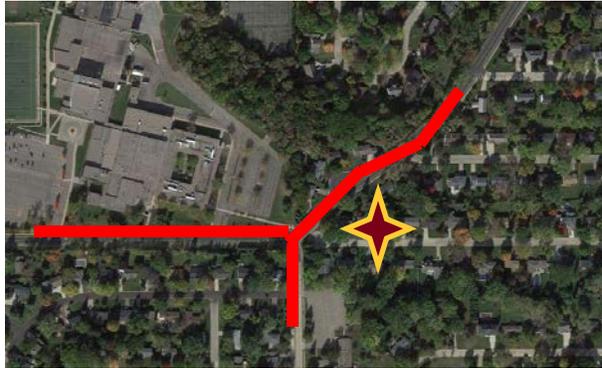
This request comes from a resident who lives within the area designated for a school speed zone, where Valley View Road's speed limit is reduced to 20 mph when children are present. However, two blocks (nearly 650 feet) before the school speed limit zone ends, there is a sign stating that the speed limit is 30 mph. The requestor believes that this makes for a confusing situation, especially for emerging skill drivers, who may not be aware that they are still

Map : Valley View Road and Antrim Road, red is the school speed limit area, the 30 mph speed limit sign is marked with a star.

After review, staff recommends maintaining the current School Speed Zone, but changing the signage by removing the End School Speed Zone signage and moving the current Speed Limit 30 signage to the End School Speed Zone sign's vacated position. This is being done to be consistent with the MNMUTCD as shown in Appendix C.

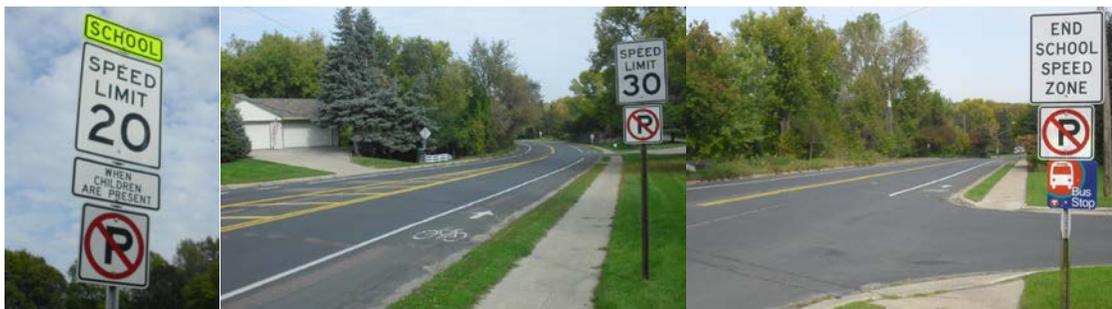
Photos : These photos illustrate the order of the signage along Valley View Road, the requestor would like to move the Speed Limit 30 sign such that it is not within the school speed zone.

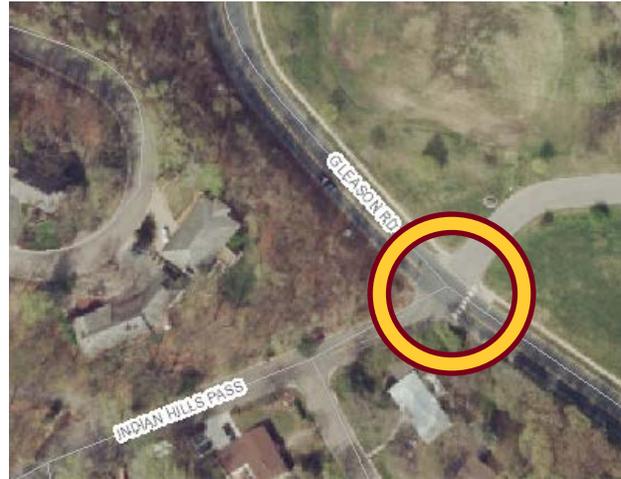
Map : Indian Hills Pass and Gleason Road

North of Creek Valley Elementary School, the school requested that the City of Edina look at the intersections of Gleason Road and Indian Hills Pass, and to a lesser extent, Creek Valley Road. A video study of Gleason Road and Indian Hills Pass was conducted. This study found that because school release is also during the evening rush hour, the traffic loads at this intersection had enough traffic on all streets to force traffic to come to a full and complete stop before entering the intersection. Several school children cross Gleason Road at this crosswalk. Awkward situations were observed, including several vehicles not yielding to pedestrians in the hours after school release, or other times when there is not enough traffic on the cross streets to “force” traffic to stop on Gleason. Another common awkward occurrence was with bicyclists crossing from the school grounds to the Indian Hills neighborhood. Because there is a sidewalk on one side of the intersection, and the crosswalk across Gleason Road connects only to a curb, and not to a sidewalk or pedestrian ramp, bicyclists cross the intersection diagonally so that they are biking on the correct side of Indian Hills Pass when they leave the school grounds. This is seen most with child bicyclists who are sidewalk-riding as they leave the school grounds. This diagonal biking has been seen as causing some confusion for drivers who appear to assume that they would be able to complete a movement at this intersection concurrent with the bicycles, as the driver’s desired movement would not conflict with a crossing in the crosswalk. There are no school patrols at this time, but a teacher is stationed at Gleason Road and Indian Hills Pass and conducts children across the street, but wears no reflective clothing nor has a sign for flagging operations.

After review, staff recommends that the school reinstate the school patrol, to bring attention to crossings related to the school day. Further, staff recommends adding a pedestrian landing pad at the south corner of the intersection, and upgrading two pedestrian ramps at the school entrance to be ADA compliant. Staff also recommends that the existing marked crosswalk be replaced with the standard school zone “ladder” crosswalk, and it be realigned slightly to match the new landing pad.

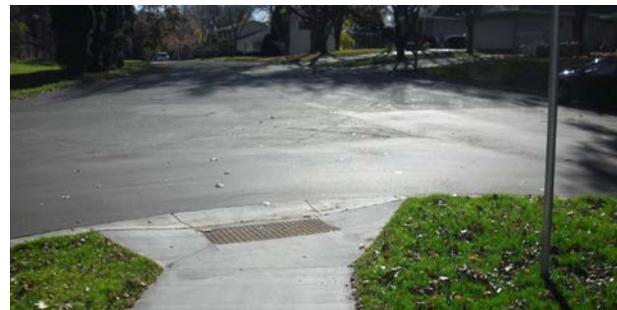
Photo : Arbor Lane and Arbor Avenue, looking south

This request comes from a resident who would like a crosswalk south from Countryside School’s schoolyard, to highlight the pedestrian movements in this area. This summer, a sidewalk was added on the east side of Arbor Avenue, along school grounds. Examination of the city’s proposed sidewalks indicates that the sidewalk in this area should extend a block further south, which was outside of this year’s reconstruction

project. This means that at this time, there is no pedestrian landing or sidewalk across the street from the existing sidewalk. A video study was performed and found that during days of normal usage the maximum number of crossings in a two hour period was seventeen (17). These volumes do not meet volume warrants for crosswalks. No crashes related to this intersection have been reported in the past five years. Full warrants may be seen in appendix A.

After review, staff recommends no action on this request, as there are not enough crossings to warrant installation of a crosswalk. Future consideration of a crosswalk should be considered when the sidewalk is constructed further, as this is seen as possibly increasing pedestrian volumes and further channelizing the crossings into one crosswalk.

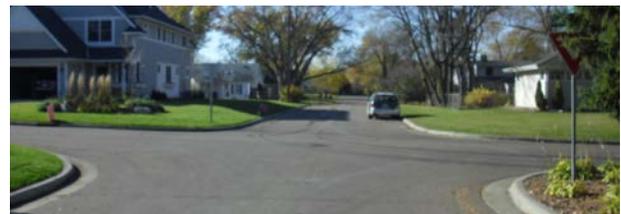
Photo : 61st Street and Oaklawn Avenue, looking west

This request comes from a resident who is concerned that previous traffic safety requests failed to consider pedestrian movements at the intersection of 61st Street and Oaklawn Avenue. Previous investigations of the area resulted in yield signs being placed for 61st Street, on the east and west legs of the intersection. A video study was performed and found that 934 movements are made in this intersection on the average day, including bicycling and pedestrian movements. This is half of what warrants would require. The number of entering movements on 61st Street is 271 while Oaklawn has 663 entering movements. Two right angle crashes have occurred at this intersection in the past five years. All these crashes have been property damage only. These crashes are seen a susceptible to correction by stop signs. Full warrants for stop signs may be seen in appendix B.

After review, staff recommends no action on this request. This recommendation considered warrants for stop signs, and existing volumes being less than half of what is needed to warrant signage. In addition the traffic patterns as observed on the camera were not seen as abnormally dangerous.

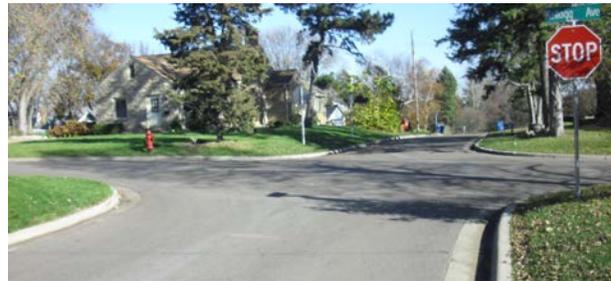
Photo : Kellogg Avenue and 59th Street, looking east

This request concerns the intersection of Kellogg Avenue and 59th Street. Currently the intersection is controlled by stop signs on 59th Street, but a request was received for the intersection to have stop signs added to it specifically. The request also included an ask for slowing traffic in the neighborhood using stop signs at intersections. Even when informed that this strategy was not used by the City of Edina and alternate traffic calming measures were presented, the requestor continued to ask for more stop signs to slow traffic in the neighborhood. Counters were placed and Kellogg Avenue was found to carry 207 vehicles per day with an 85th-percentile speed of 28.1 mph. These numbers are very similar to studies conducted in 2007, 2012 and 2013 on this roadway. 59th Street was seen as carrying 85 vehicles per day with an 85th-percentile speed of 17.9 mph. This may be due to the extremely narrow construction of 59th Street, which is only 18 feet wide east of Kellogg and 23 feet wide west of Kellogg. Complete warrants for stop signs can be seen in appendix B.

After review, staff recommends no action on this request. Counters placed did not observe excessive speeds, and stop sign warrants were not met. Using stop signs to control volumes and speeds is not recommended by the City of Edina.

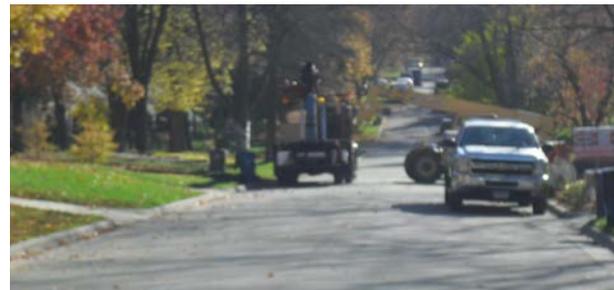
Photo : Kellogg Avenue looking south from 59th Street, even with a 27 foot roadway, two sided parking can make a narrow driving surface.

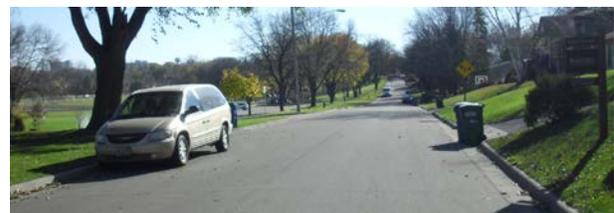
Photo : Oaklawn Avenue, looking south from 59th Street

This request concerns traffic on Oaklawn Avenue, which is perceived to be very fast moving and detrimental to the safety and tranquility of the area. A counter was placed in this location and found that an average of 422 vehicles use Oaklawn Avenue in this location, with an 85th-percentile speed of 29.7 mph. Only one crash has occurred in the last five years on this stretch of Oaklawn Avenue, this was a rear-end crash which was determined to be due to driver distraction.

After review, staff recommends no action on this request. The requestor's concerns were not supported by traffic data.

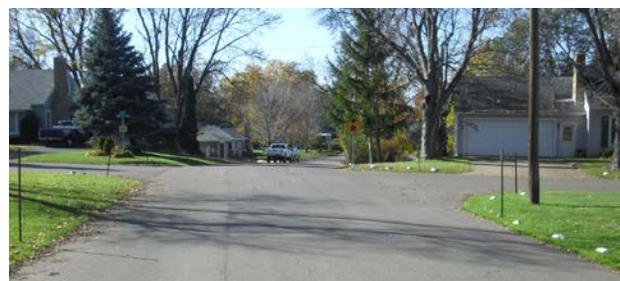
Photo : 57th and Abbott, looking west

This request concerns the intersection of 57th Street and Abbott Avenue. 57th Street has 226 ADT and a 25 mph 85th-percentile speed from a 2014 study. A 2015 count on Abbott Avenue found that the street had 140 ADT and 23.8 mph 85th-percentile speeds. There has been one crash at this intersection in the last ten years, in 2007, as a vehicle southbound and eastbound collided in the intersection. The crash did not result in injury and was not noted as having any influencing or improper factors by the reporting officer. This intersection had some sightline issues, of which those covered by city ordinance have been removed. The intersection also is skewed, with the streets connecting at an angle of approximately 70-degrees instead of the full 90-degrees associated with the grid in the surrounding area. This skew can make some drivers uncomfortable. Full warrants for stop signs may be seen in appendix B.

After review, staff recommends no action on this request. This recommendation considers the lack of warrants met, and no recent crash history.

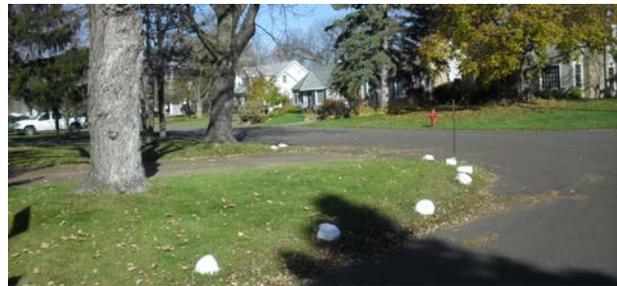
Photo : Sight obstructions on the north side of the intersection

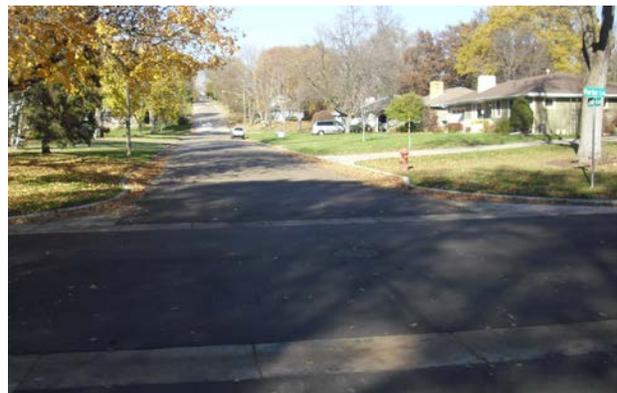
Photo : Code Avenue at Porter Avenue

Over the summer, traffic from the Birchcrest B roadway reconstruction projects was perceived by residents as detouring down Code Avenue to reach Benton Avenue. Residents had concerns that traffic patterns would remain, and that the vehicle traffic was traveling too quickly as it descended a hill north of 60th Street and south of Porter Avenue. While data was not collected during the construction season due to the needed street sweeping in the area, counts taken after construction revealed that 369 vehicles per day used Code Avenue and the 85th-percentile speed was 27.9 mph. Both Porter Avenue and 60th Street maintain their crown through the intersection and create vertical deflection, acting slightly like speed bumps in reducing vehicle speeds. This area will be reconstructed in 2017. There have been two crashes on Code Avenue in the past five years, neither of which appear to be related to speed.

After review, staff recommends no immediate action be taken on Code Avenue. This request has been forwarded and added to the Birchcrest A reconstruction, which will include this street, such that calming measures may be added in the 2017 reconstruction.

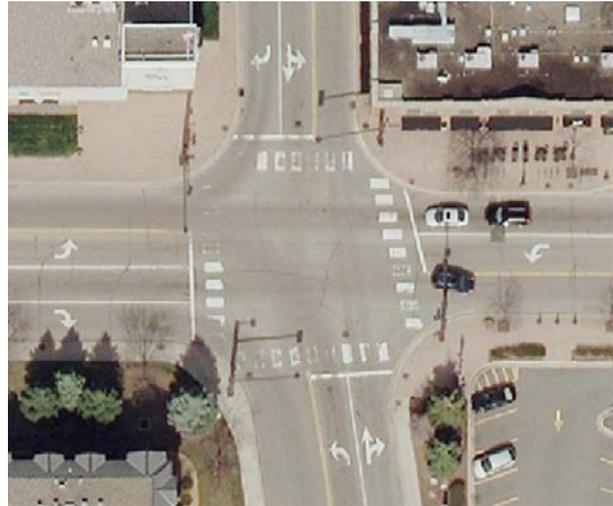
This request concerns the lane assignments on Halifax Avenue as it intersects 50th Street. Currently there are two lanes entering the intersection on both the north and south approaches. On the north side, there is a right-turn only lane and a shared left/through lane, while on the south side of the intersection there is a left-turn only lane and the right lane is a shared right/through lane. The requestor feels that this set up is confusing and causes persons traveling north to assume that the lane assignments for southbound traffic mirror their own, and thus begin their left turns in front of oncoming traffic. There have been no crashes at this intersection in the past five years that reflect such confusion.

Photo : This is a close up aerial of the intersection of Halifax Avenue and 50th Street

After review, staff recommends no action on this item. There have been crashes at this intersection, but none of them reflect the scenario as described by the requestor. Therefore, there is no evidence that this situation causes dangerous confusion. The requestor did not leave contact information with staff to be informed of this recommendation.
