**Date:** April 20, 2017

**To:** Edina Transportation Commission

**From:** Nick Bauler, Traffic Safety Coordinator

**Subject:** Traffic Safety Report of April 05, 2017

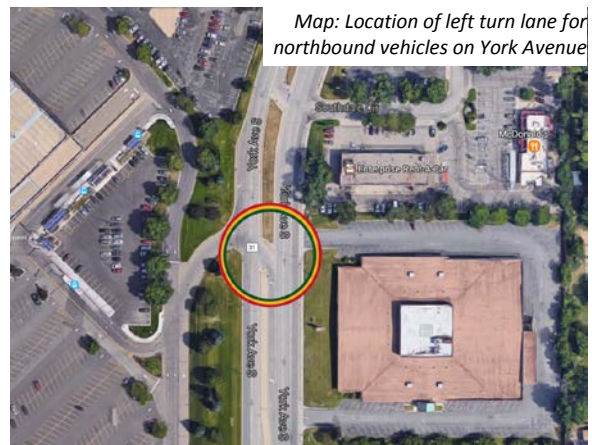
Map: Location of left turn lane for northbound vehicles on York Avenue

AI. Request to place a 'No Left Turn' sign on southbound York Avenue into the entrance of 6725 York Avenue.

- Northbound buses turning left into Southdale are unable to complete this turn as southbound vehicles turning left enter the turn lane.
- Requester claims issue is often between 5:30 and 6:00 am.
- Northbound vehicles turning left into Southdale have a marked left turn lane. There is no left turn lane for southbound vehicles for the new apartment complex.
- A 'Do Not Enter' sign faces 6725 York Ave to prevent exiting vehicles from entering the turn lane illegally.

**After review, staff recommends contacting Hennepin County to request placing a 'No Left Turn' sign in the median of York Avenue to prevent southbound vehicles turning left into 6725 York Avenue.**

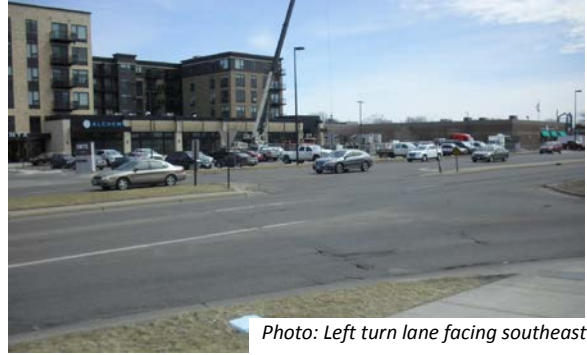
*Photo: Left turn lane facing southeast*

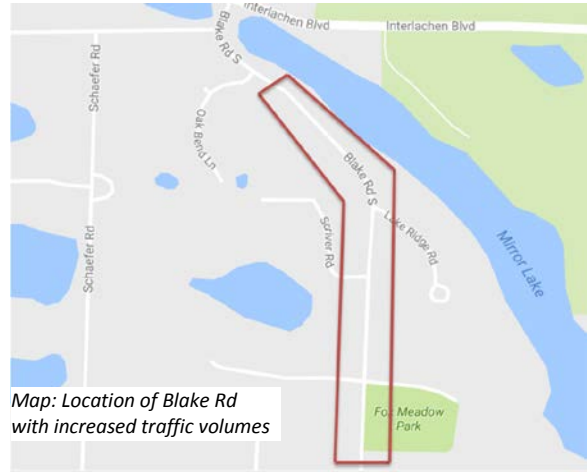
*Map: Location of Blake Rd with increased traffic volumes*

**A2. Request for traffic calming on Blake Road in response to increased traffic following Highway 169 closure.**

- A resident was concerned with the increased traffic stating Blake Rd has become unsafe, and drivers attempting to turn onto Blake Rd believe there are not enough gaps.
- Speed limit on Blake Rd is 30 MPH
- ADT on Blake Rd at Fox Meadow Park in 2013 was 2,671 with average speeds of 37.5 mph.
- ADT at same location in 2017 is 4,401 (65% increase) with average speeds of 39 mph.
- AM peak hour in 2013 was 10:30 am with 184 vehicles, in 2017 the peak hour is 7:45 with 385 vehicles.
- PM peak hour in 2013 was 4:30 pm with 275 vehicles, in 2017 the peak hour is 5:15 with 527 vehicles.

**After review, staff recommends increasing police enforcement on Blake Road during peak hours. Edina will continue monitoring Blake Road over the summer.**

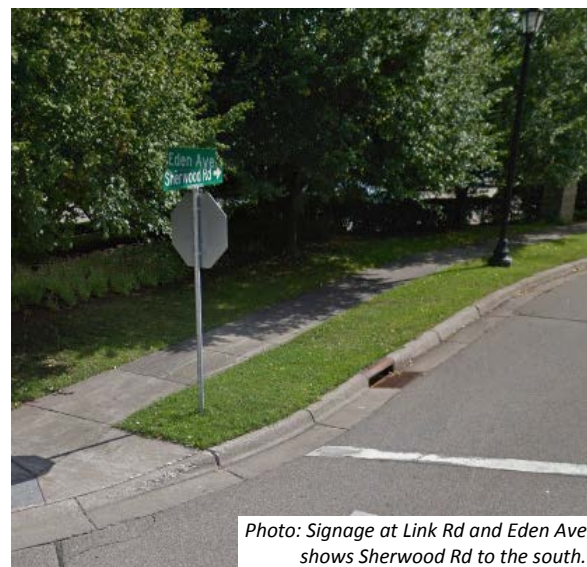
*Photo: Signage at Link Rd and Eden Ave shows Sherwood Rd to the south.*

- A resident requested to make Eden Ave run west up to Vernon Ave as people would be informed by GPS units to turn from Vernon Ave onto Link Rd.
- Link Rd has no signage at Vernon Ave or on Eden Ave.
- Eden Ave transitions into Sherwood Rd at the west exit of Grandview Square Park.
- Eden Ave and Link Rd are listed as 'Connector Streets'
- Vernon Ave is listed as a "Minor Arterial Street"

**After review, staff recommends the resident who made the request to file a petition to City Council. The petition will indicate the residents affected are in favor of the change. If the petition/request is approved, Edina will contact Hennepin County towards this request to update signage along Vernon Avenue.**

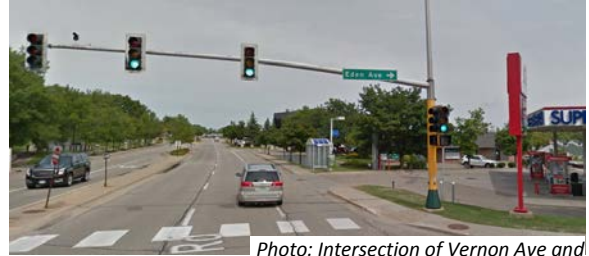
Photo: Intersection of Vernon Ave and Link Road signage shows Eden Ave

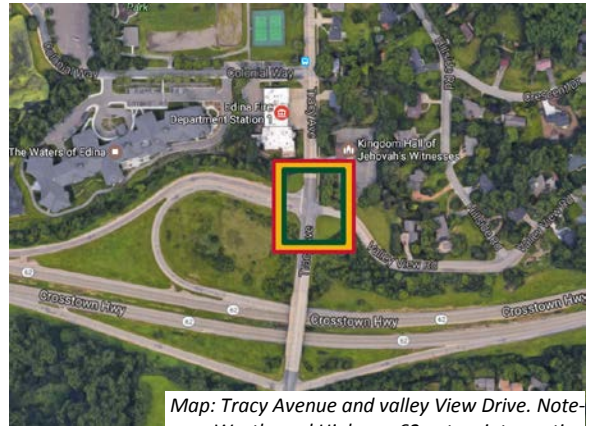
Map: Tracy Avenue and valley View Drive. Note- Westbound Highway 62 enters intersection

- Tracy Avenue runs north and south and is currently uncontrolled. Valley View Road connects to the east side of Tracy Avenue, and the west approach serves as an exit from Minnesota State Highway 62.

- Tracy Avenue is classified as a collector street and has an ADT of 7,490 at the intersection with a peak hour of 846 at 5 pm.
- Valley View Road is classified as a local connector and the Minnesota State Highway exit is classified as a principal arterial. These roads have an ADT of 3,891 with a peak hour of 327 at 6 pm.

- Tracy Avenue is the major approach and exceeds 300 vehicles/hour 12 times/day. Valley View Road is the minor approach and exceeds 200 vehicles/hour 10 times/day. This meets all-way stop warrants.

**After review, staff recommends to review this intersection following summer construction. With the addition of marked lanes/lane assignments on the east leg of the intersection, total vehicle delay may improve.**

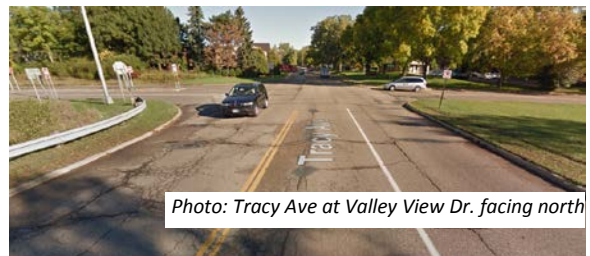
Photo: Tracy Ave at Valley View Dr. facing north
